Filtek™
Supreme XTE
Universal Restorative

Clinical Case: by Dr Terry Wong B.Sc (HONS) Melb B.D.sc (Melb)

Patient Case:

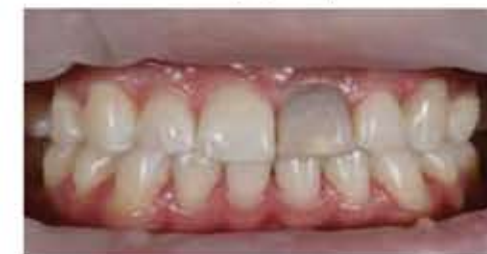
Figure 1.

The patient is a 20 yr old male, who sustained damage to his upper right central incisor from a bicycle accident approximately 8 yrs ago. The tooth underwent root canal therapy and the damaged incisal edge was repaired with a composite restoration. According to the patient, the tooth went dark shortly afterwards.

The patient came to see me for correction of the discolouration and also closure of the patient's Diastema.

The patient was going overseas shortly, so there was little time to spare. It was suggested to try non-vital tooth whitening in view of the difficulty on relying on composite resin alone, to mask this dark discolouration. (Figure 1)

A periapical radiograph was taken to ensure a good root filling was present. The palatal composite was removed. Gutta Percha (GP) was found in the coronal areas and subsequently removed from the coronal space. A glass ionomer seal was placed over the GP before placement of the whitening mixture of sodium perborate/water.

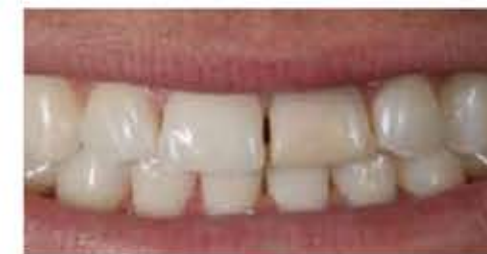
Figure 2.

Two applications of the whitening mixture was carried out over 8 days, however the significant reduction in darkness occurred after the first whitening procedure over 6 days. (Figure 2)

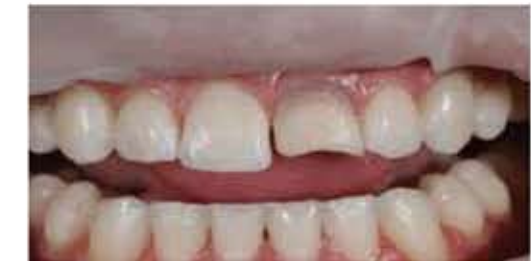
Figure 3.

The patient returned on day 8 for the final restoration. The old composite was removed and the access cavity was sealed with glass ionomer. There was minimal labial tooth preparation. The enamel was maintained on the labial surface.

The enamel surface was etched for 15 seconds, rinsed off before the application of one coat of Universal Scotchbond. This was light cured for 10 seconds. (Figure 3)

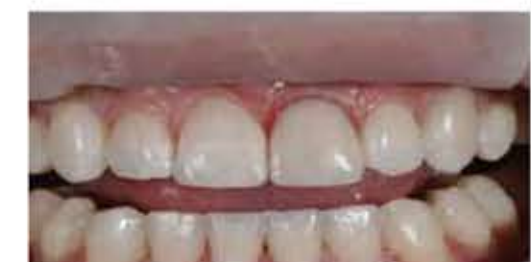
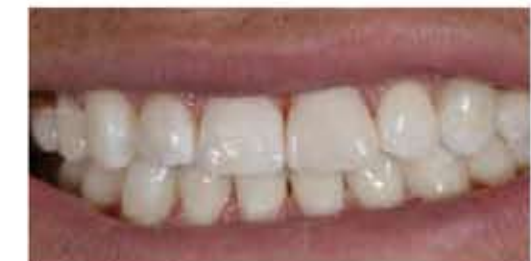
Figure 4.

The discoloured cervical area was covered with a composite flowable opaque mixture (Creative Colours – Pink: A2.5)

Filtek Supreme XTE was chosen as the composite to complete the case.

A1Dentine shade was applied to the cervical area. White Enamel and XWBody shade combination to the remaining labial surface.

The diastema was closed by the addition of shade A1D to the mesial surface of tooth 11. (Figure 4 & Figure 5)
